Contents

Introduction

This audit covers the area bounded by Martin Luther King Jr. Boulevard, on the east by Trinity Street, on the south by 10th Street, and on the west by Lavaca Street. Outlying buildings include the William P. Clements Building located at 300 West 15th Street and the Ernest O. Thompson Building located at 920 Colorado Street.

Capitol Grounds South of 15th Street

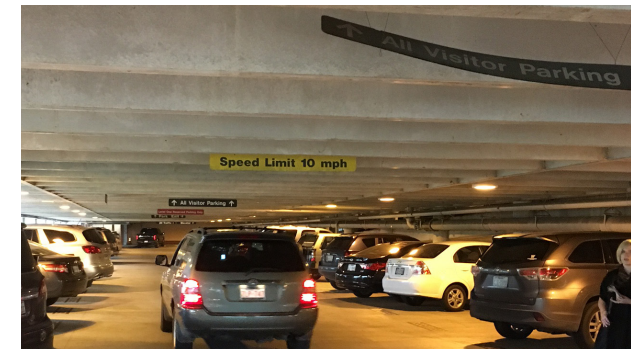
2 Interior Garage Signage is damaged which hinders functionality.

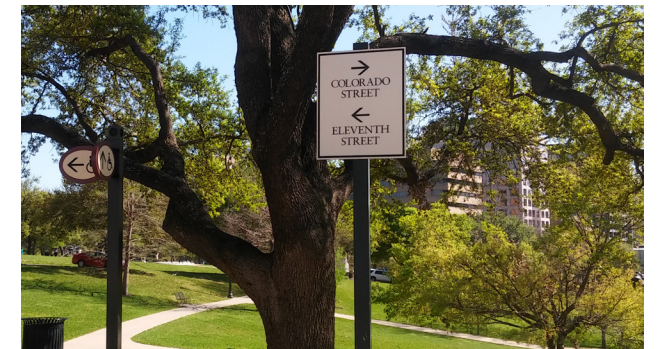
3 Pedestrian Signage within Capitol Grounds directs to adjacent streets but not to surrounding destinations or landmarks.

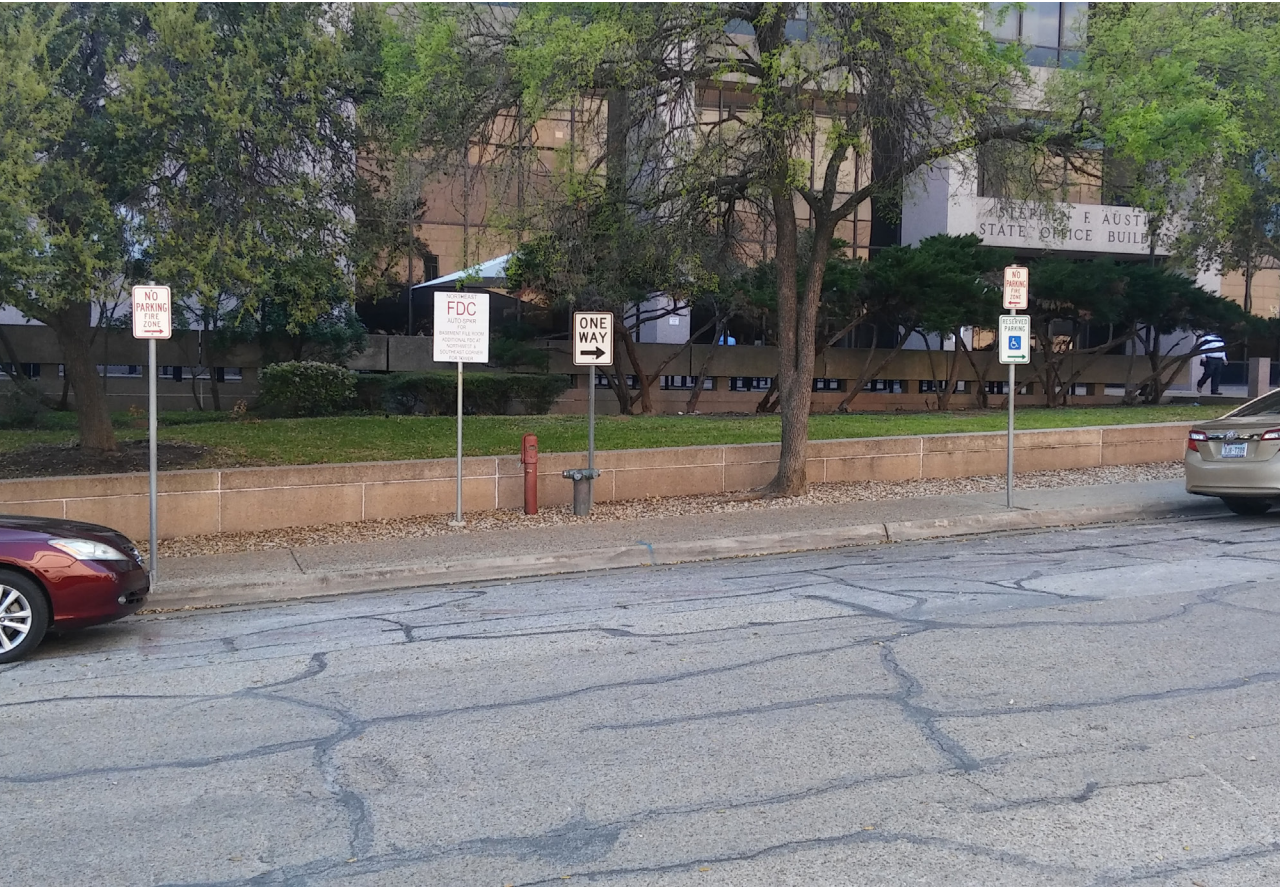
Regulatory signage varies in size and height. Signage visually clutters the environment. No clear datum line.

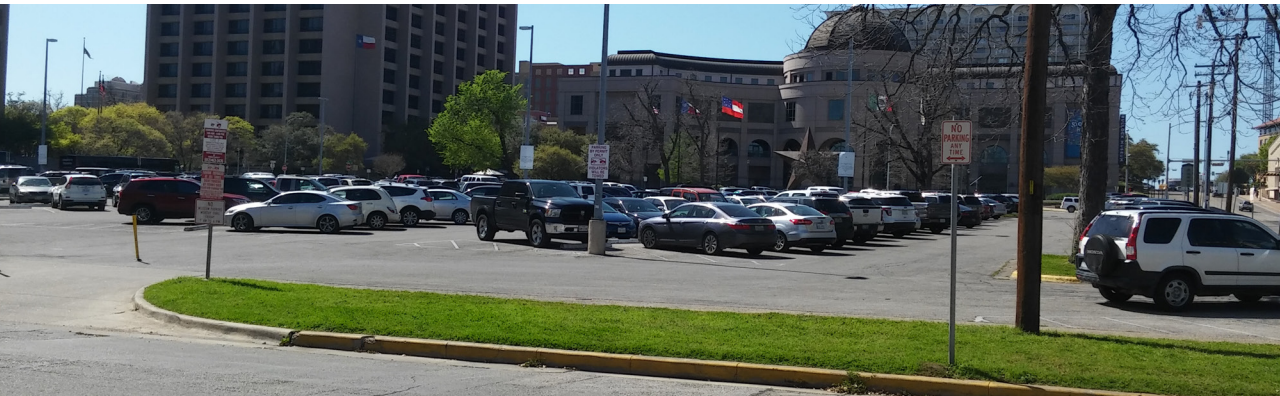
Regulatory signage is generally overwhelming and often duplicative in nature. Signage does clearly indicate what type of permit is necessary for each parking lot.

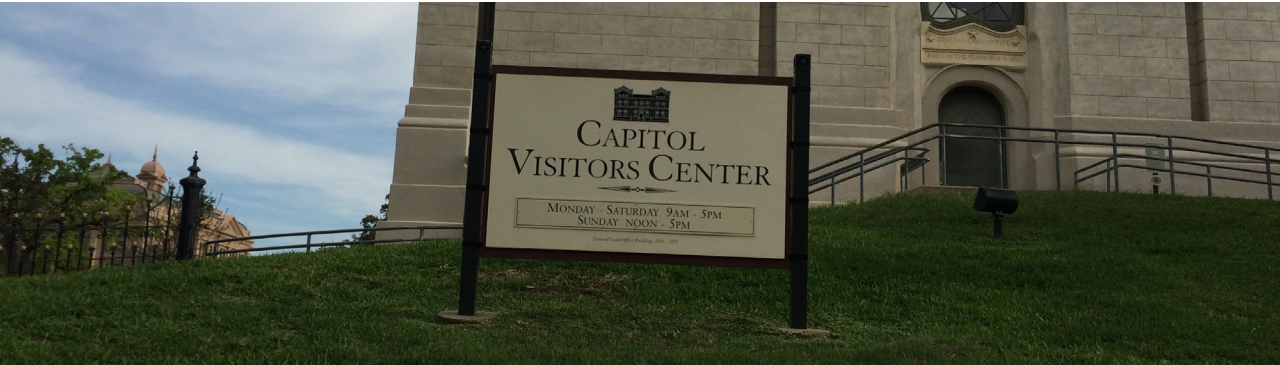
2 Capitol Visitor's Center Signage varies in format.

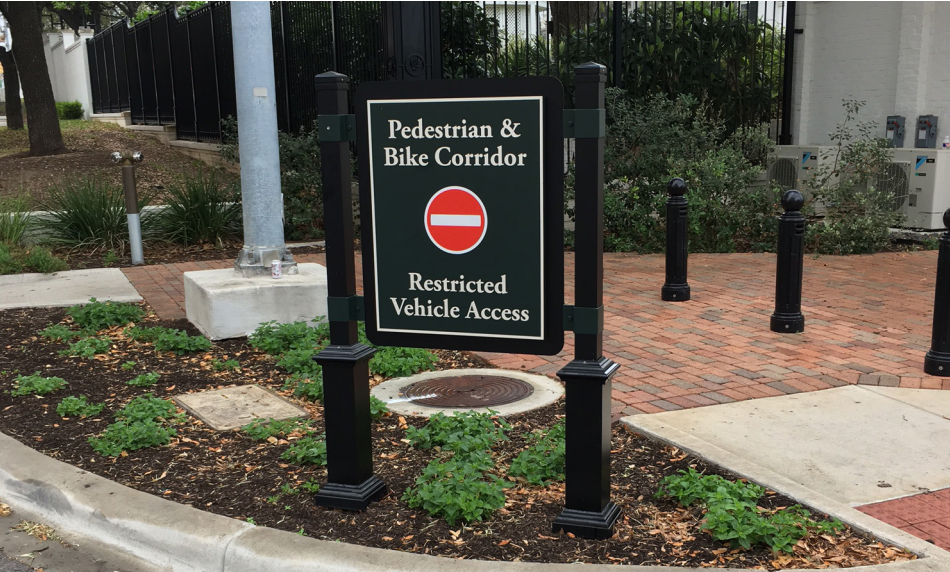
2 Regulatory signage surrounding the Mansion is unwelcoming and non-official in presentation.

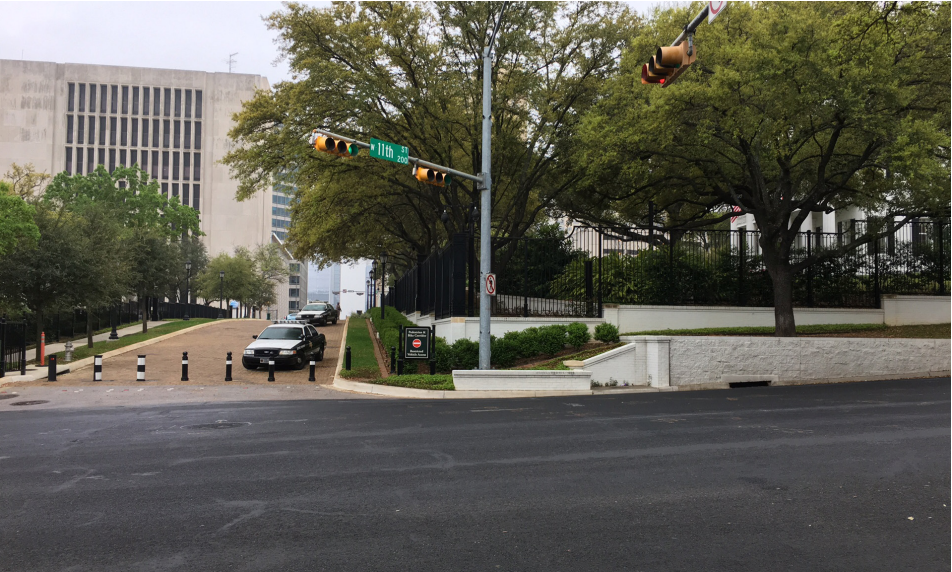
2 There are no public sidewalks that surround the Governor's Mansion, forcing pedestrians into traffic.

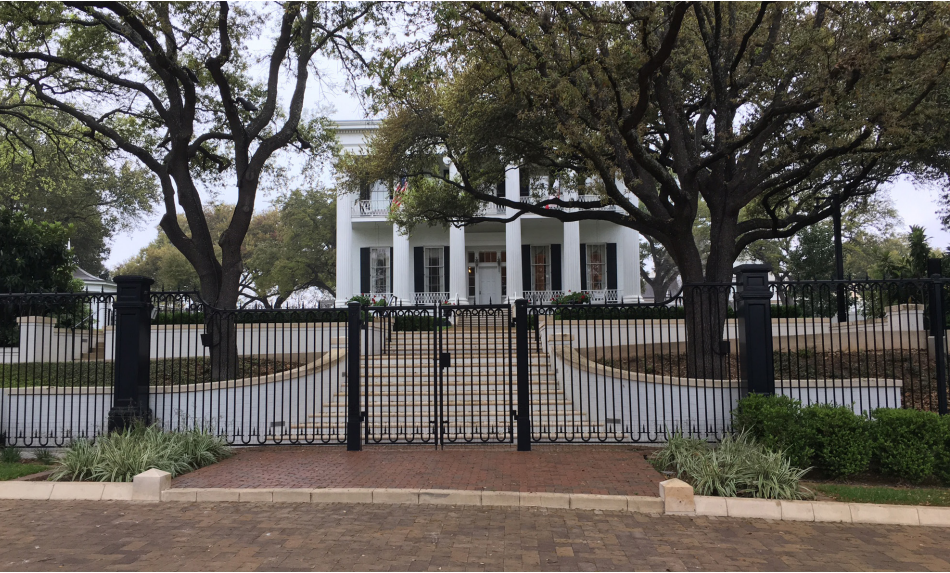
2 The Governor's Mansion is not clearly marked for visitors.

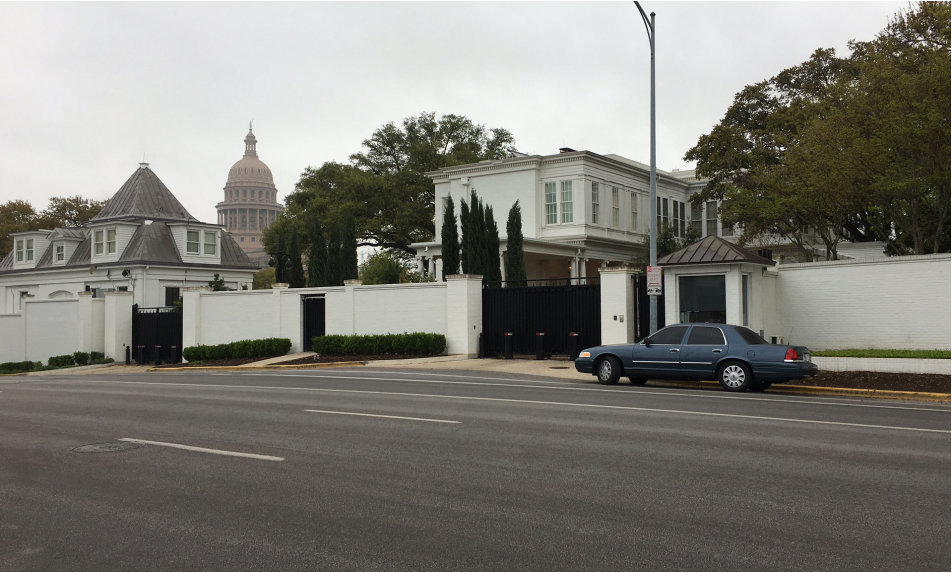
2 The Governor's Mansion is not clearly identifiable for vehicles at typical distances.

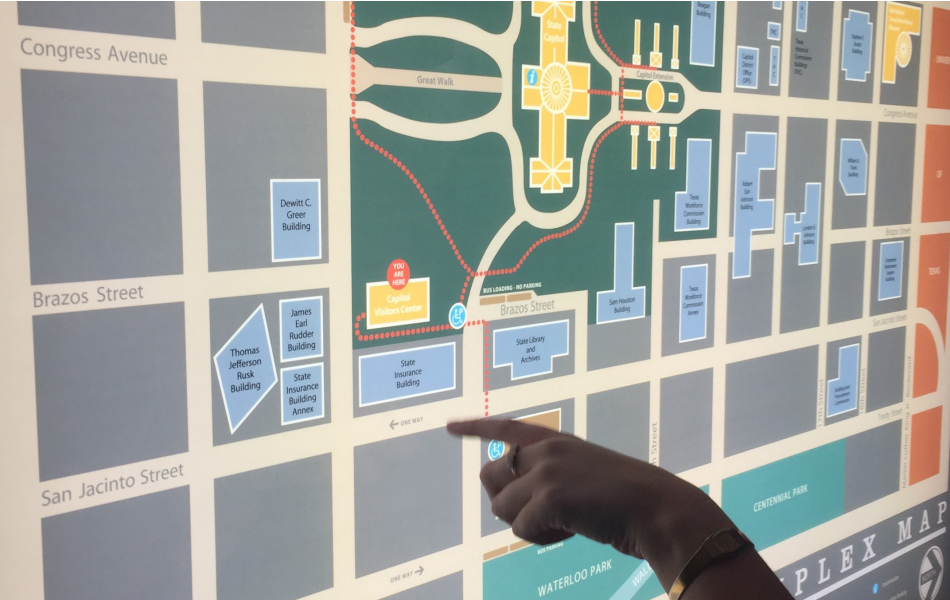
2 Map styling is inconsistent throughout the Capitol Grounds.

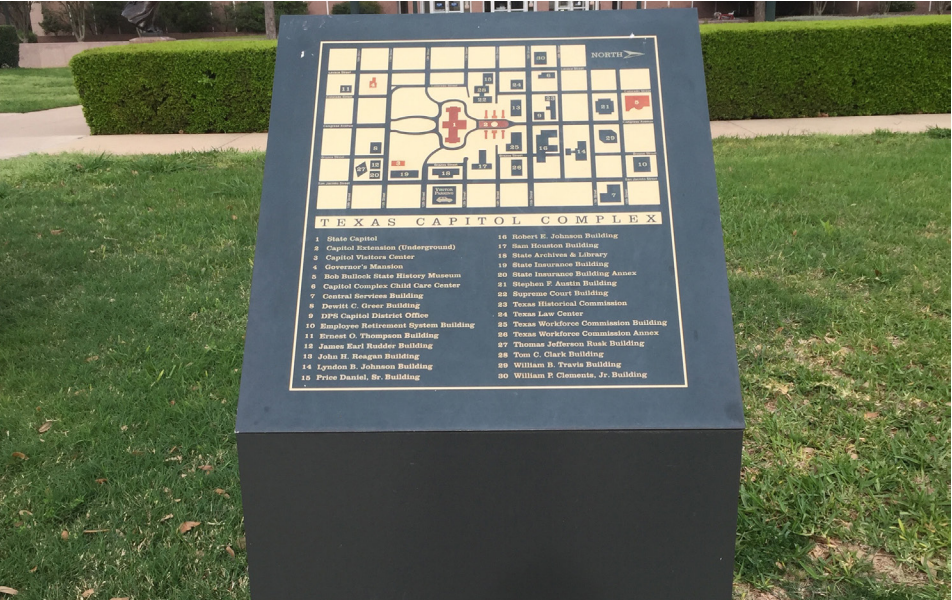
2 There are a minimal amount of orientation maps throughout the site.

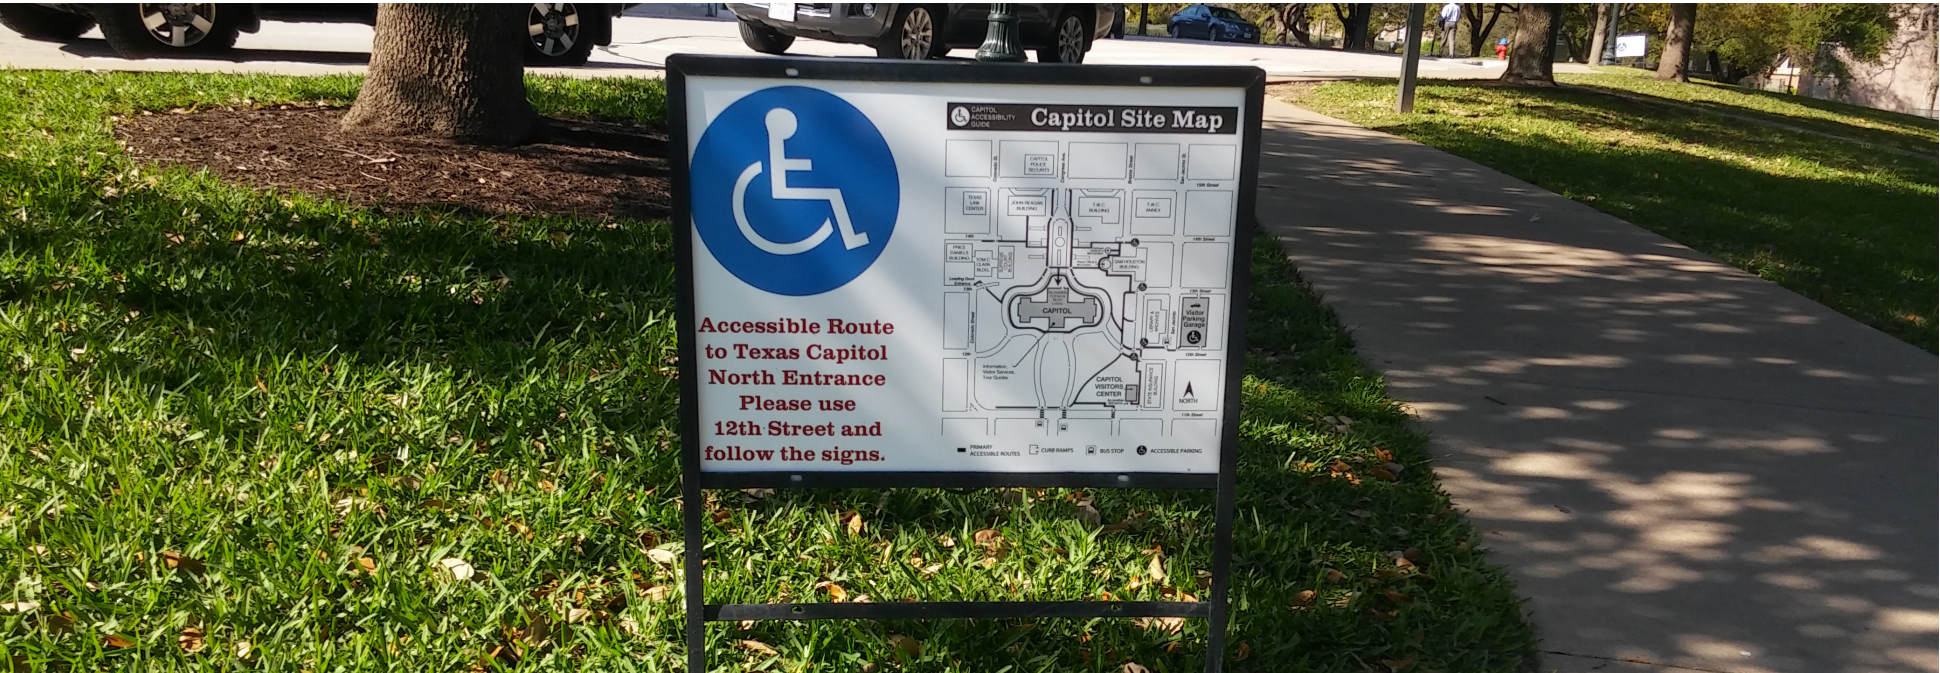
2 Orientation maps are placed poorly and not highly visible to the user.

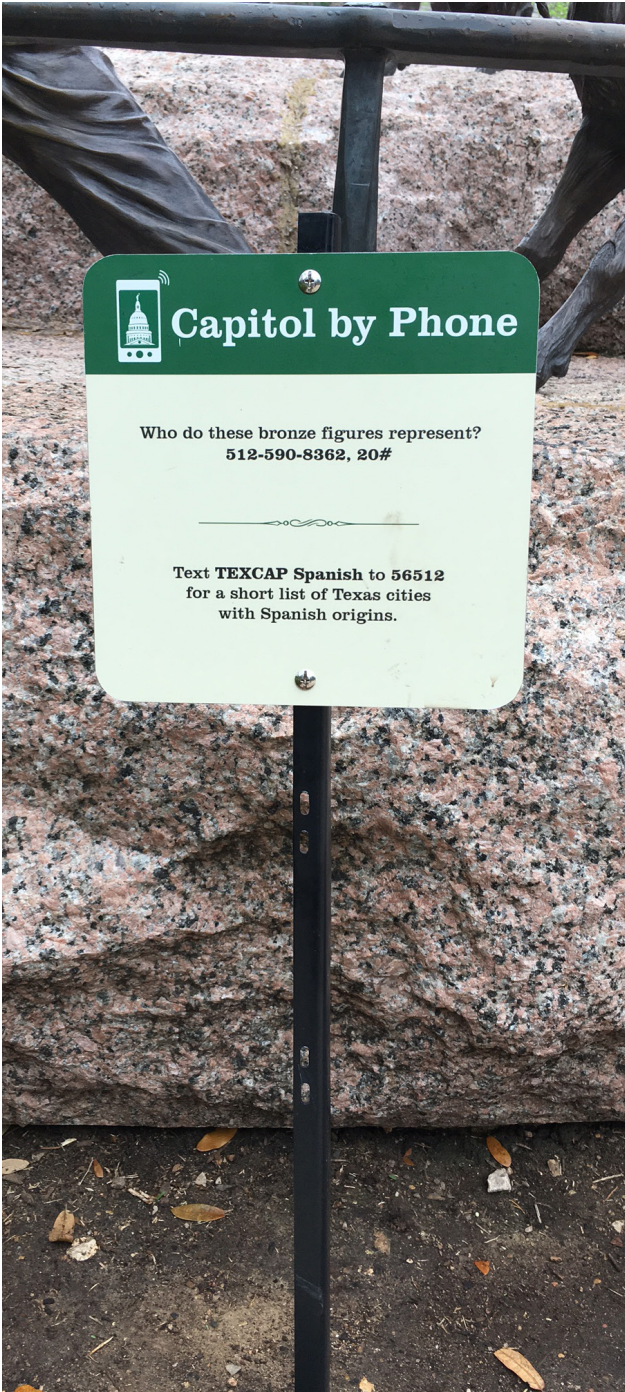
3 Some signs suggest the user to use their phone, others suggest to use a QR code. The user interaction is inconsistent.

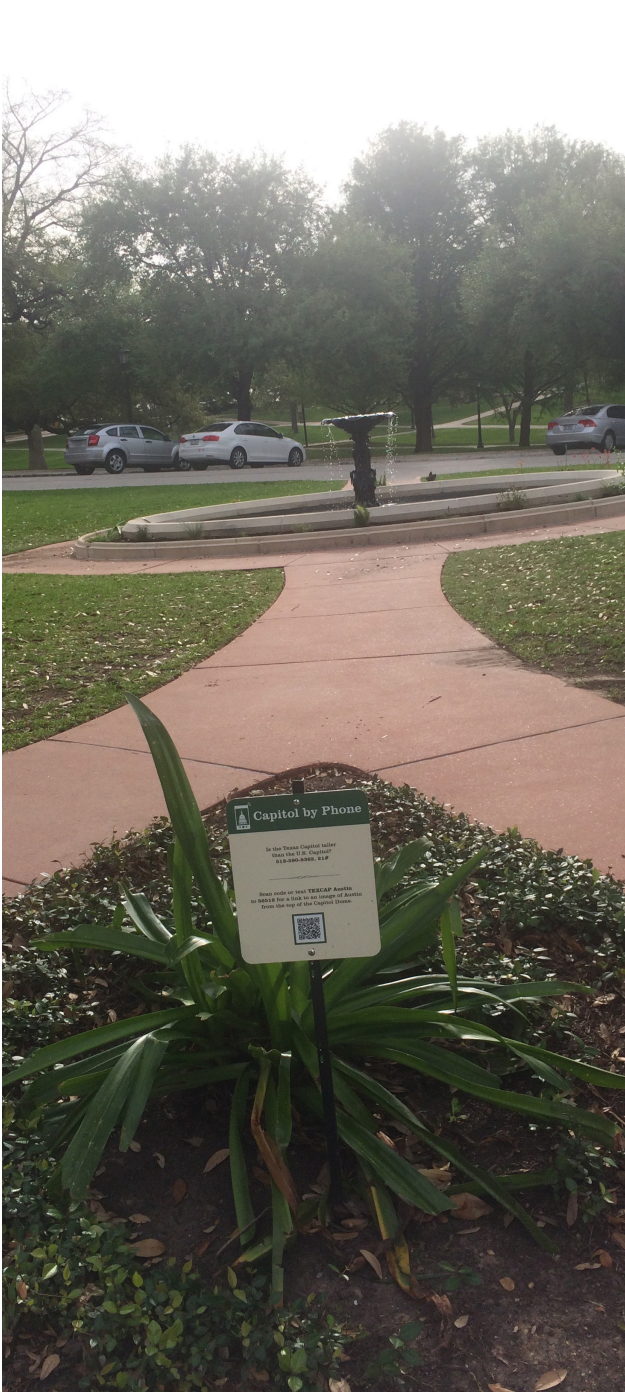
3 User interaction signage could be placed in more visible locations.

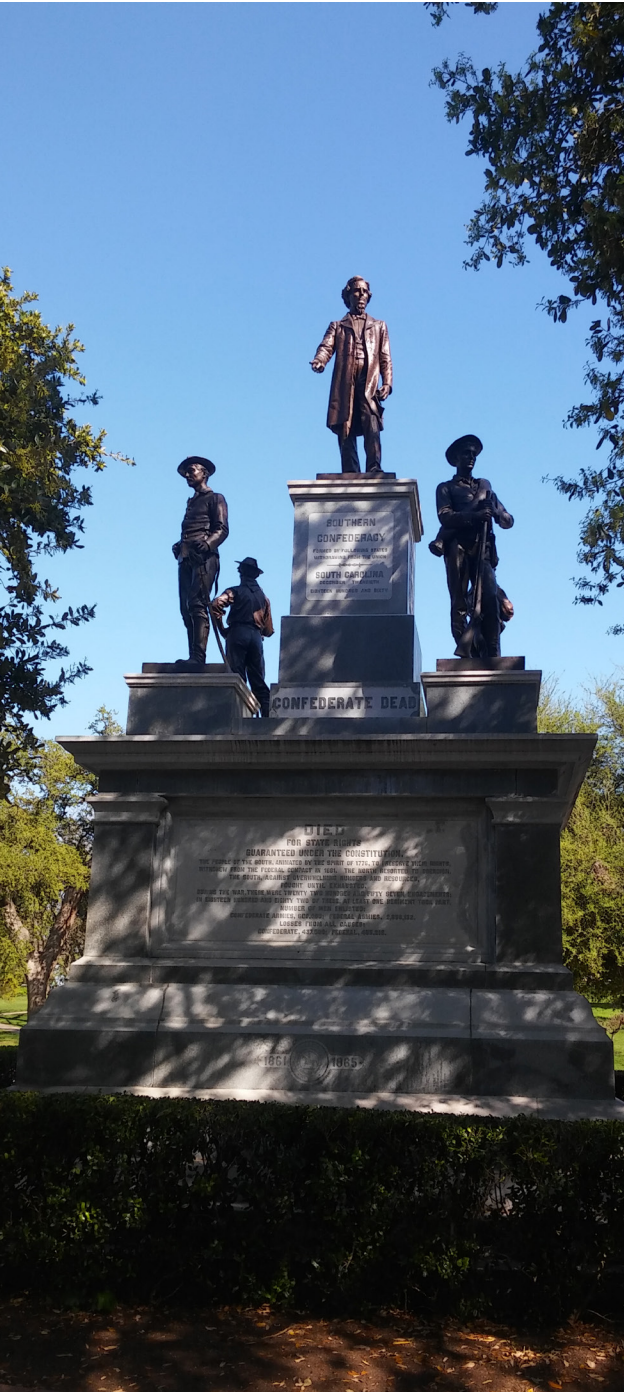
3 Not all monuments have opportunities for User Interaction. There is not a directory for the location of monuments.

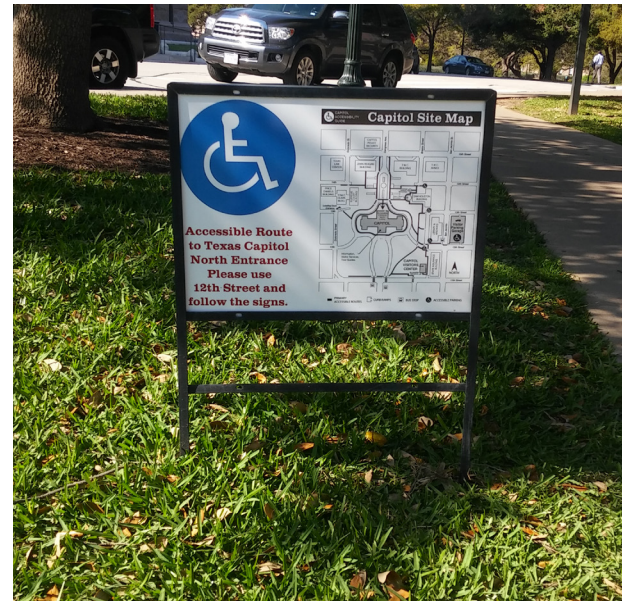
② Temporary Signage is used throughout the Capitol Grounds for Accessible Route identification.

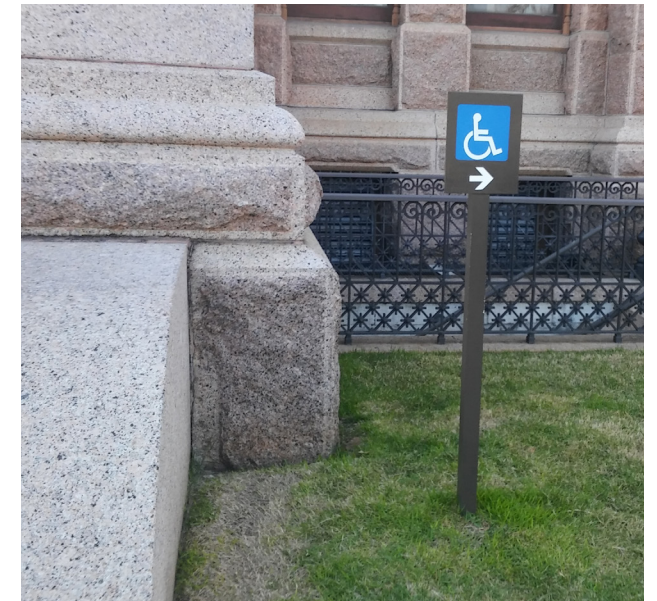
② Accessible Route ID's vary in placement and in visibility to the user.

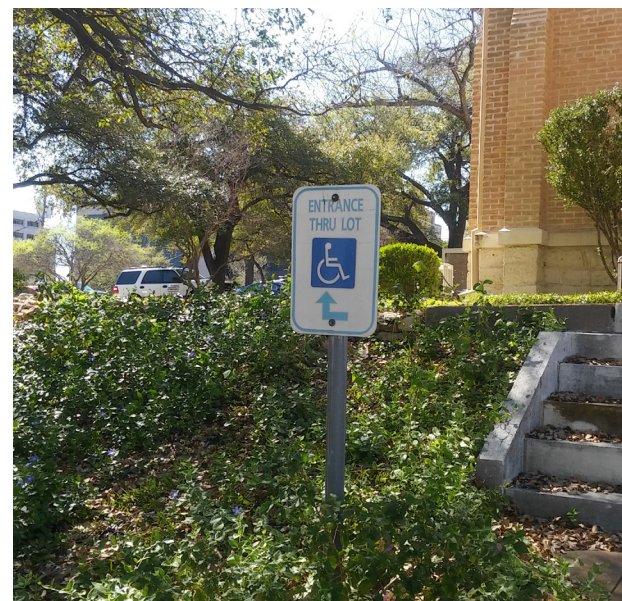
Accessible Route Signage varies in styling, messaging and overall presentation.

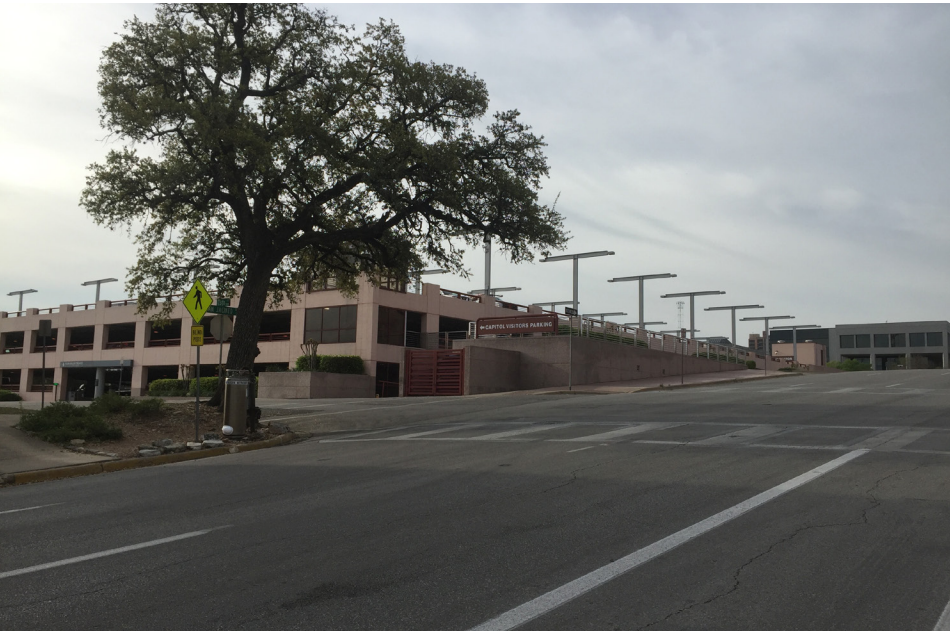
3 Wayfinding Signage directing to the Capitol Visitor's Garage Entrance is minimal.

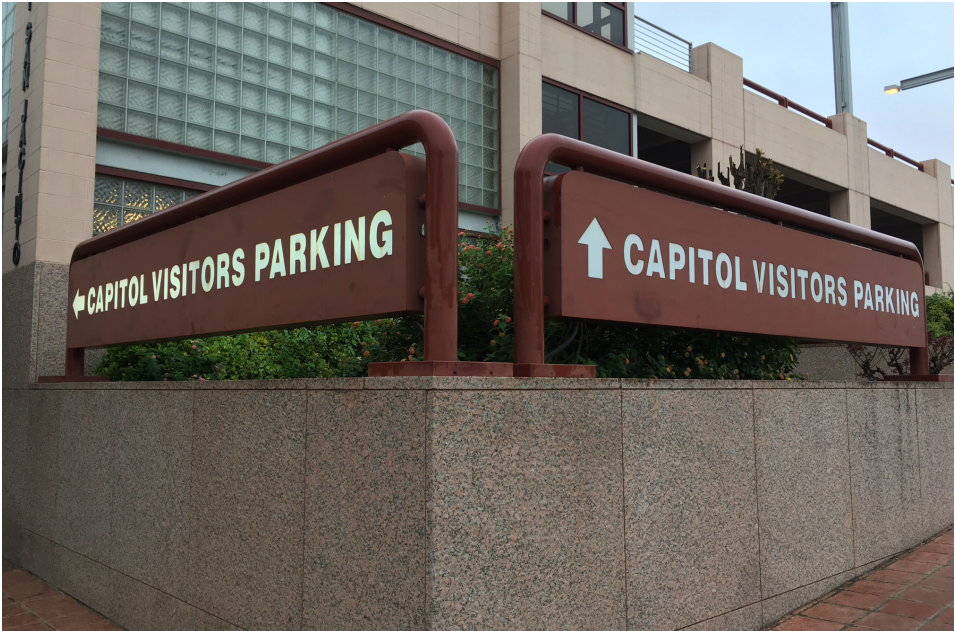
3 Branding is not consistent with wayfinding signage within Capitol Grounds.

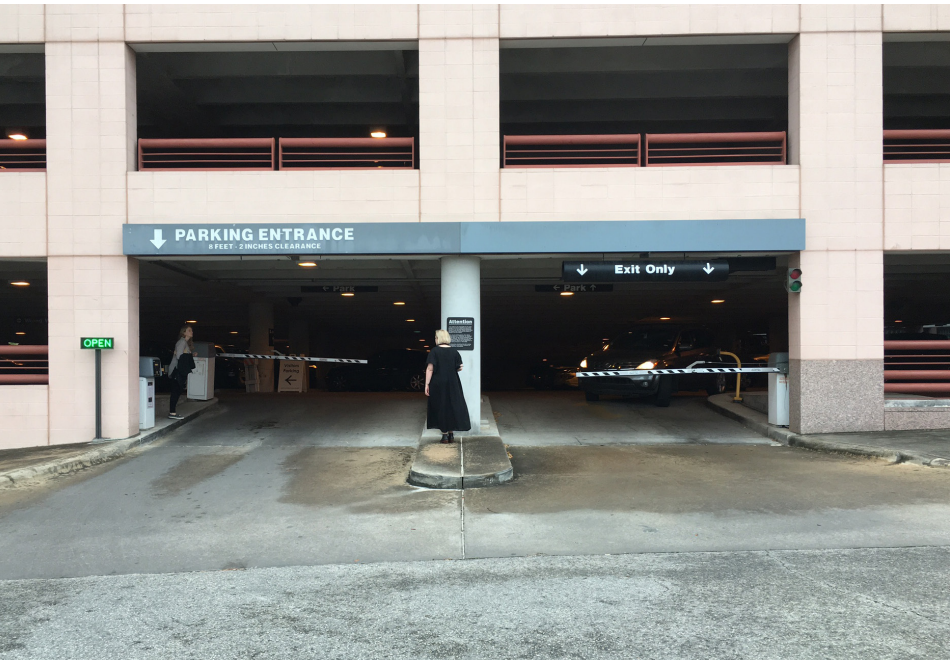
3 Clearance information varies from each entryway.

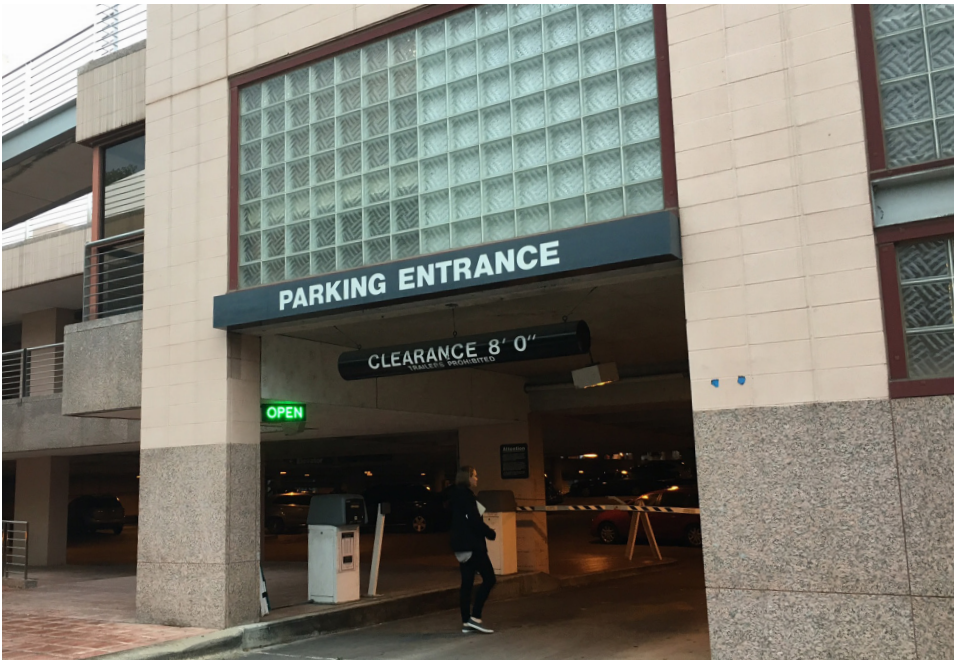
3 Some entrances contain a clearance bar and others list the clearance information.

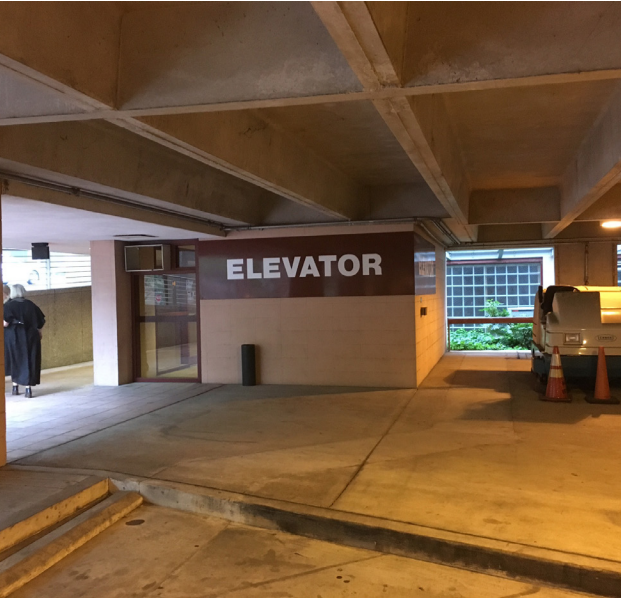
3 Interior Garage Wayfinding directs to elevators but not to exit pathways.

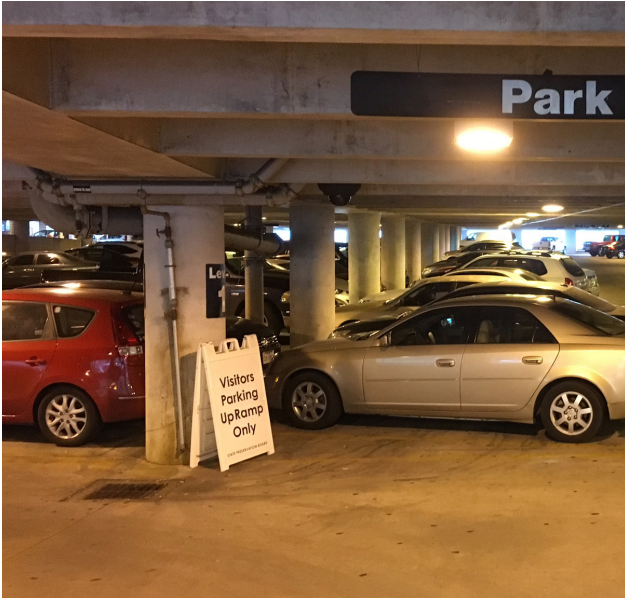
3 Temporary Signage is used throughout the Garage for wayfinding needs.

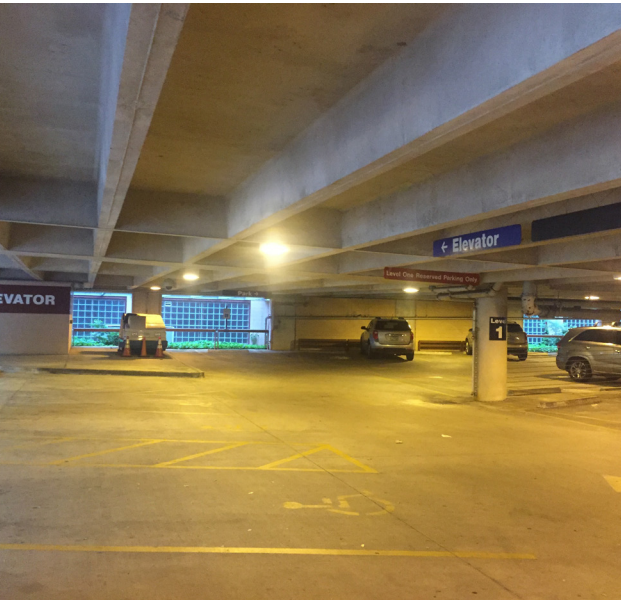
3 Overall design is not consistent with wayfinding signage within Capitol Grounds.

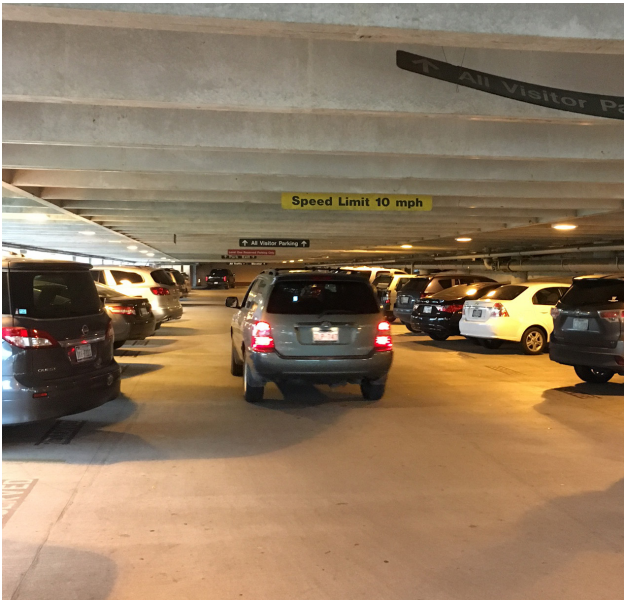
3 Interior Garage Signage is damaged which hinders functionality.

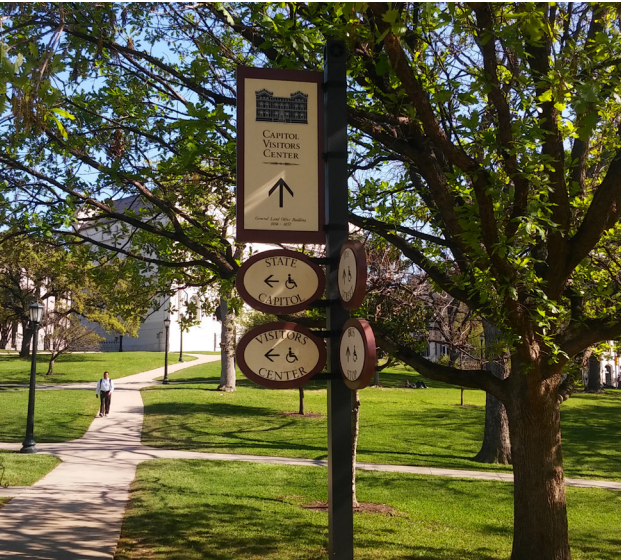
3 Primary Wayfinding Signage and Accessible route signage is overwhelming to the user.

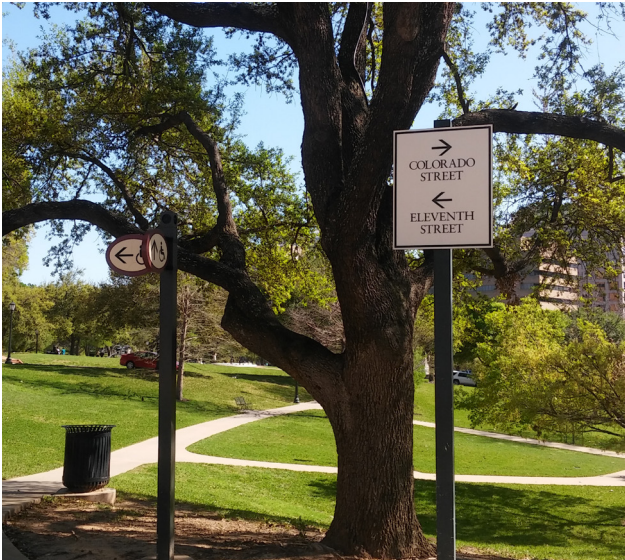
3 Wayfinding and Accessible route signage differs in format and style.

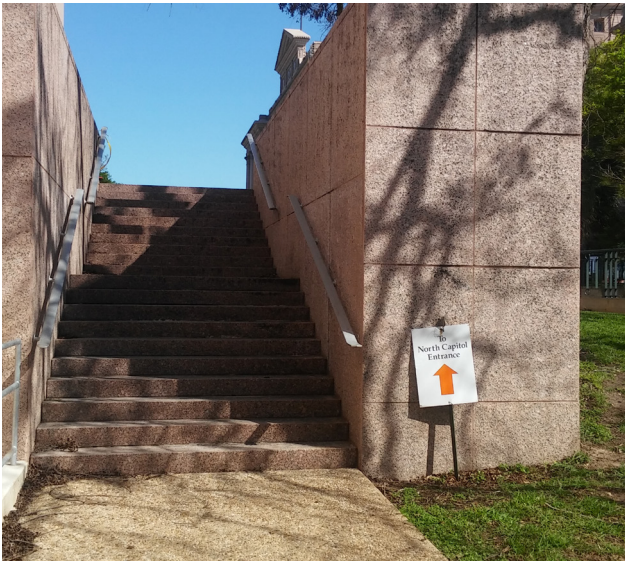
3 Temporary signage is used for Capitol Grounds wayfinding experience.

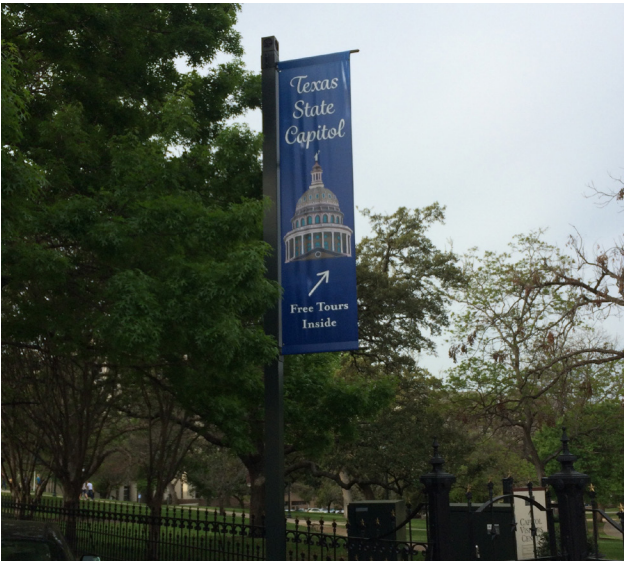
3 Capitol Gateway ID's are not consistent with other signage within the Capitol Grounds.

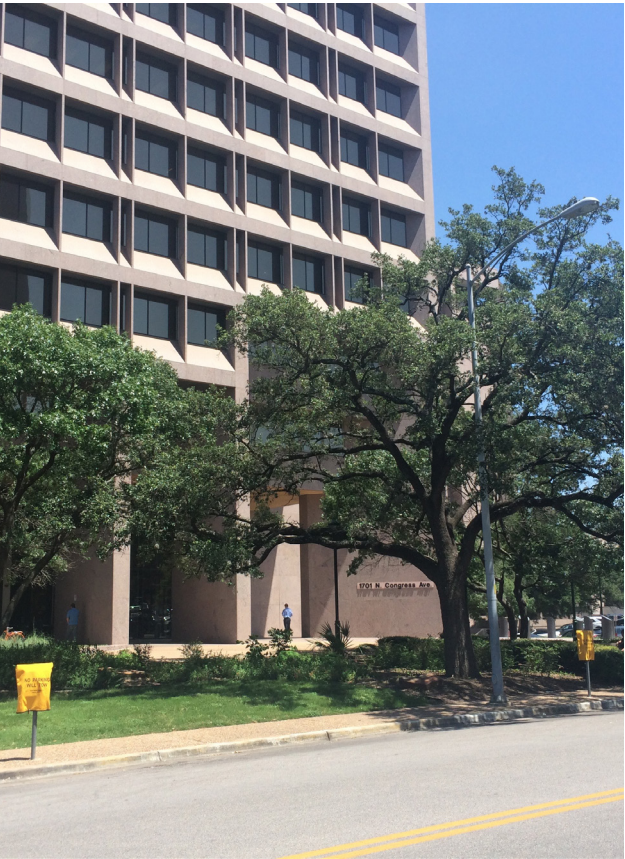
4 Identification for the William B. Travis Building is obscured by landscaping.

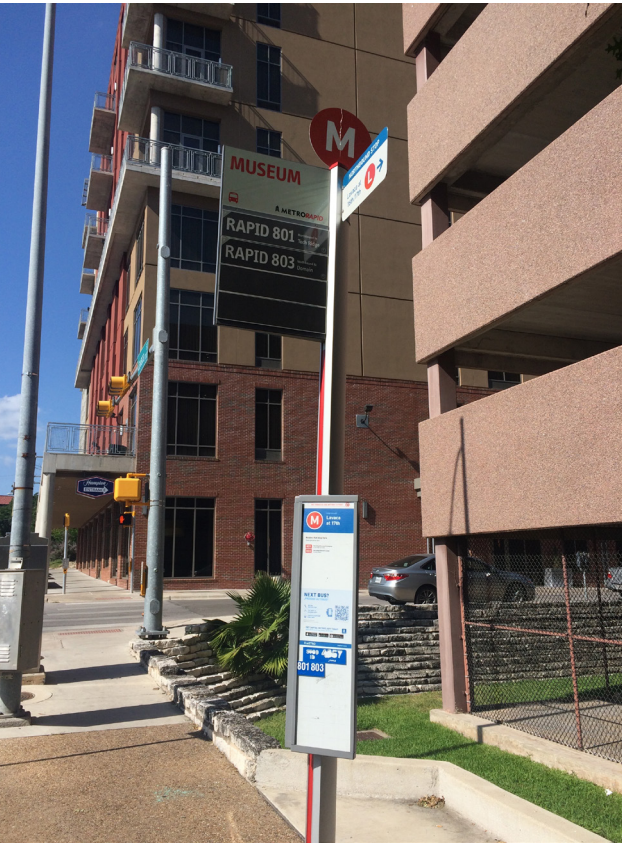
6 Bus stop signage is owned and installed by the city and varies in quality and visibility.

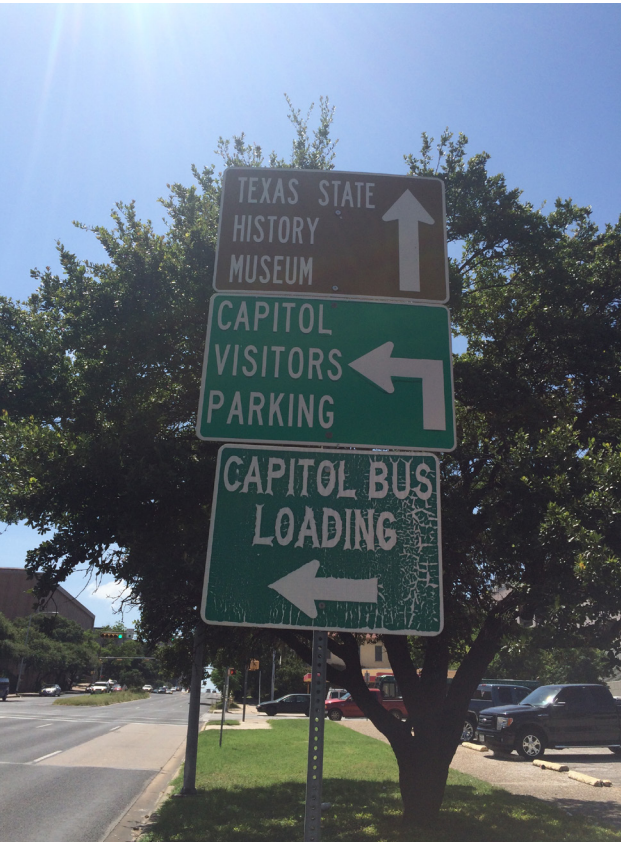
7 The majority of Vehicular Directionals are owned by the city and poorly maintained.

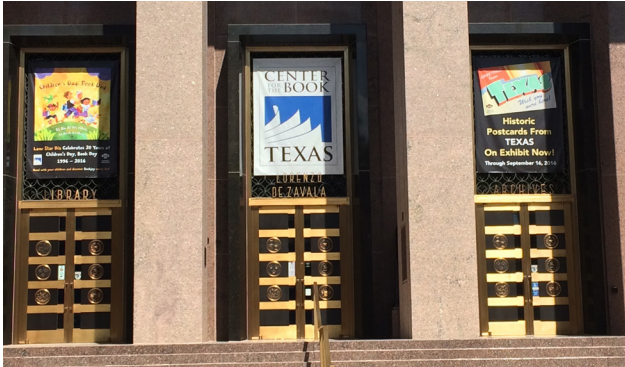
Entries with good signage are overwhelmed by large temporary signage.

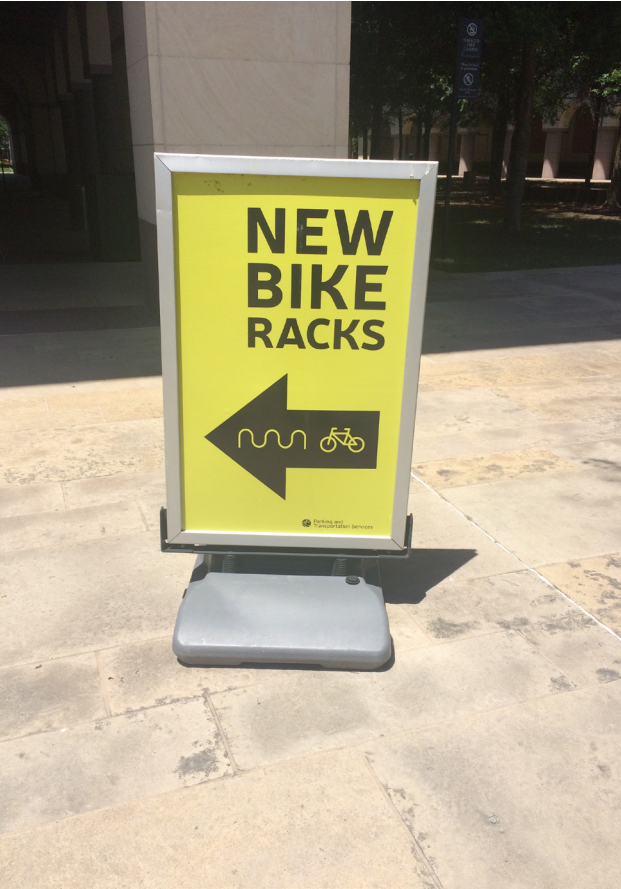
4 The Blanton provides clearly visible markers that notate available Bike Racks to the user.

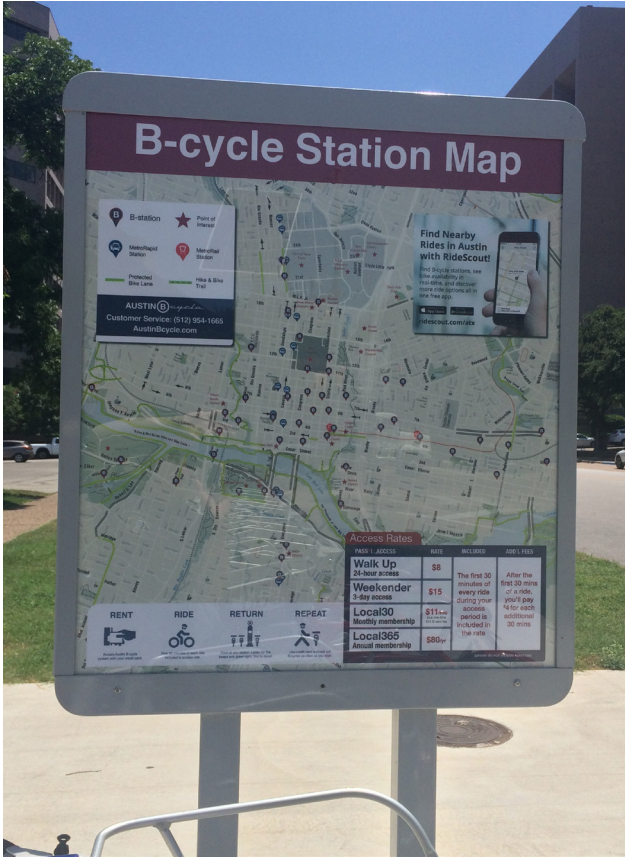
4 B-Cycle maps clearly identify The University of Texas and Capitol Grounds but they do not identify the bounds of Capitol Complex or Texas Facilities Commission.

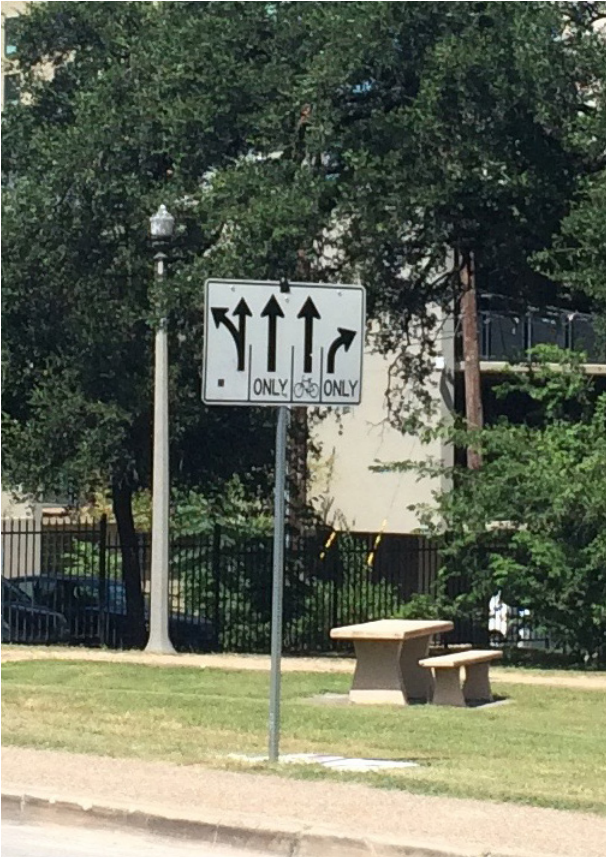
5 Signs that identify bike lanes are minimal and typically represented through city signage.

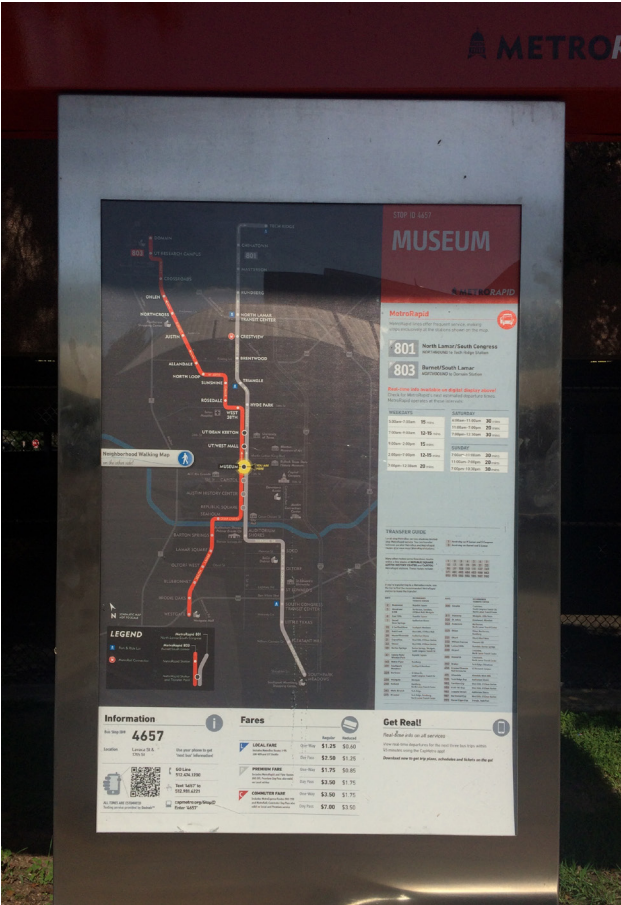
6 Routes do not denote Capitol Complex.

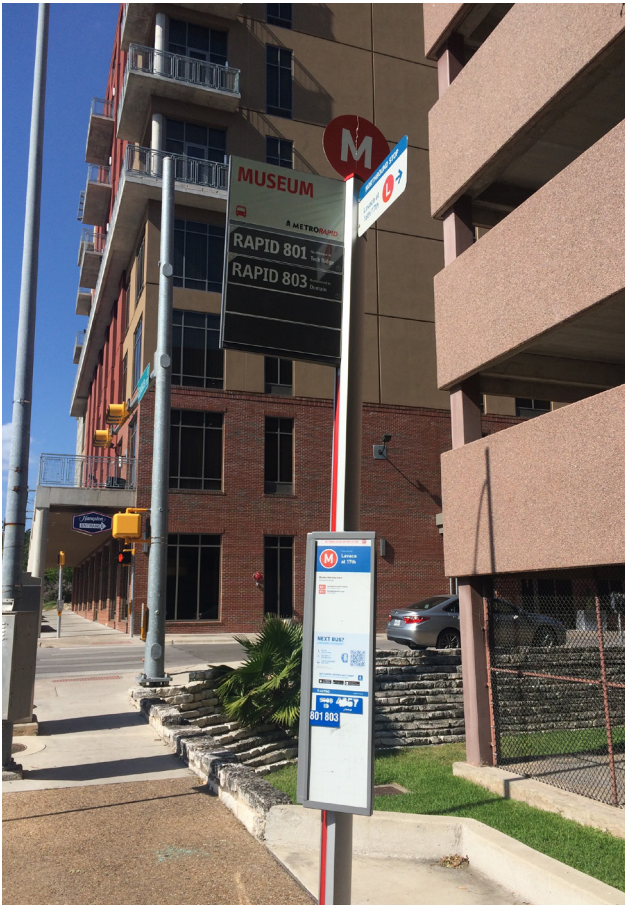
6 Signs and bus stops are owned and installed by city and vary in quality and visibility.

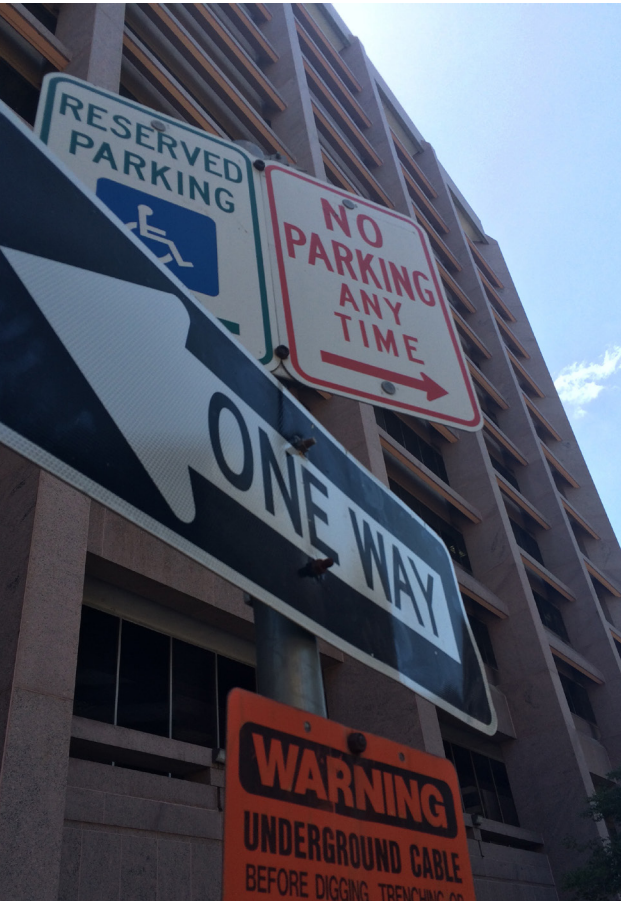
7 Inconsistent installation methods overwhelm some sign infrastructure.

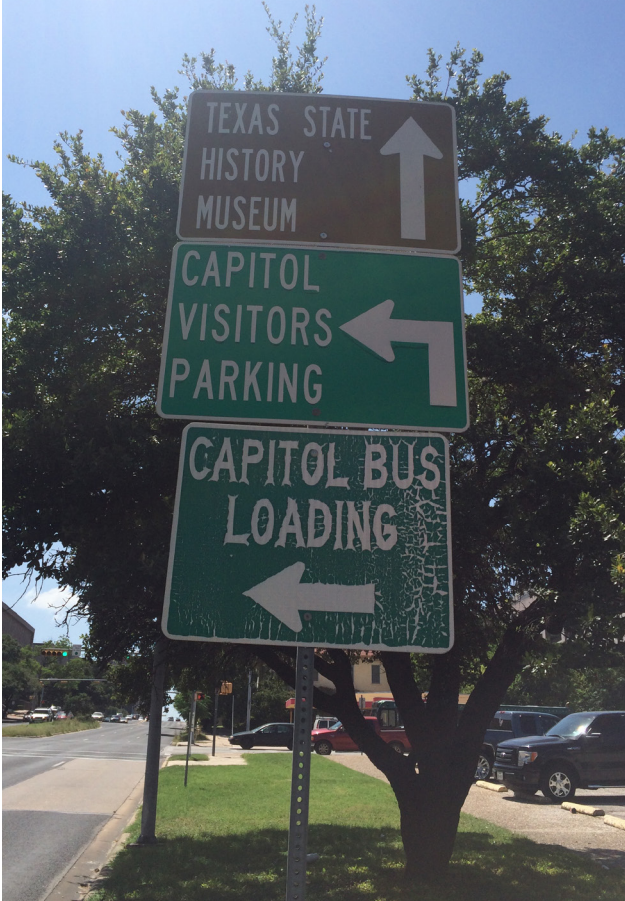
7 The majority of vehicular directionals are owned by the city and are poorly maintained. Signage does not note Capitol Complex.
